Carol Stream Park District Coral Cove Water Park Evaluation

June 16, 2021

Prepared By:
WT Group

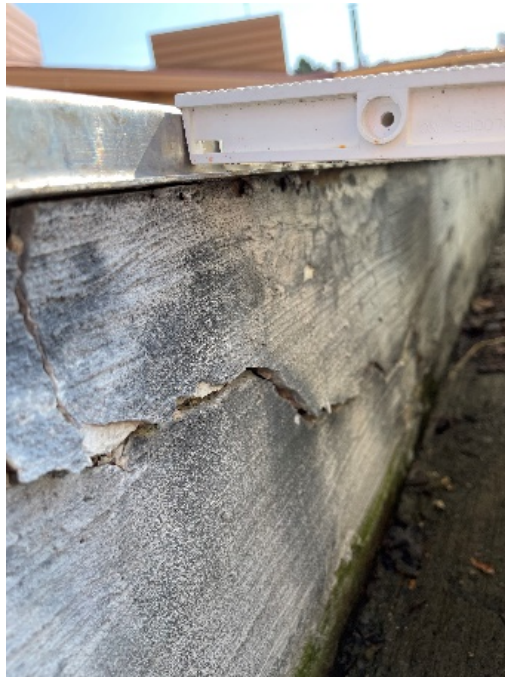
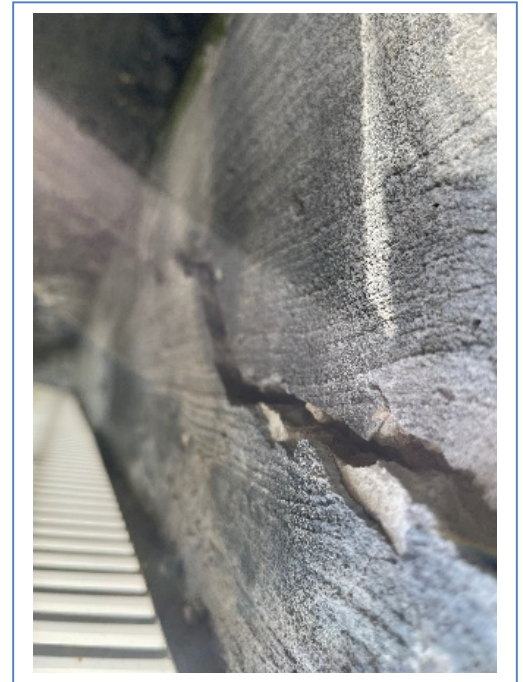
1. The zero depth concrete gutter has significant cracking on the walls of the gutter trough. Staff indicated that there are numerous areas throughout the gutter where there are cracks.

4. The main pool zero depth gutter has significant cracking that is most likely a source of water loss. The zero depth gutter concrete trough should be repaired.

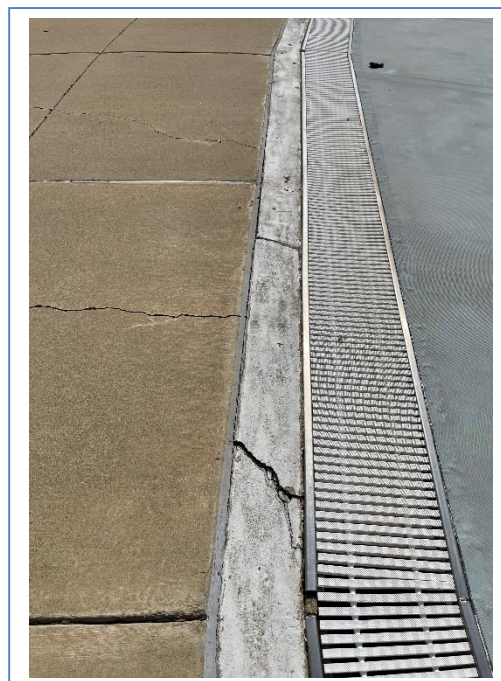
2. The top of the concrete gutter wall, adjacent to the pool deck has cracking in many areas.

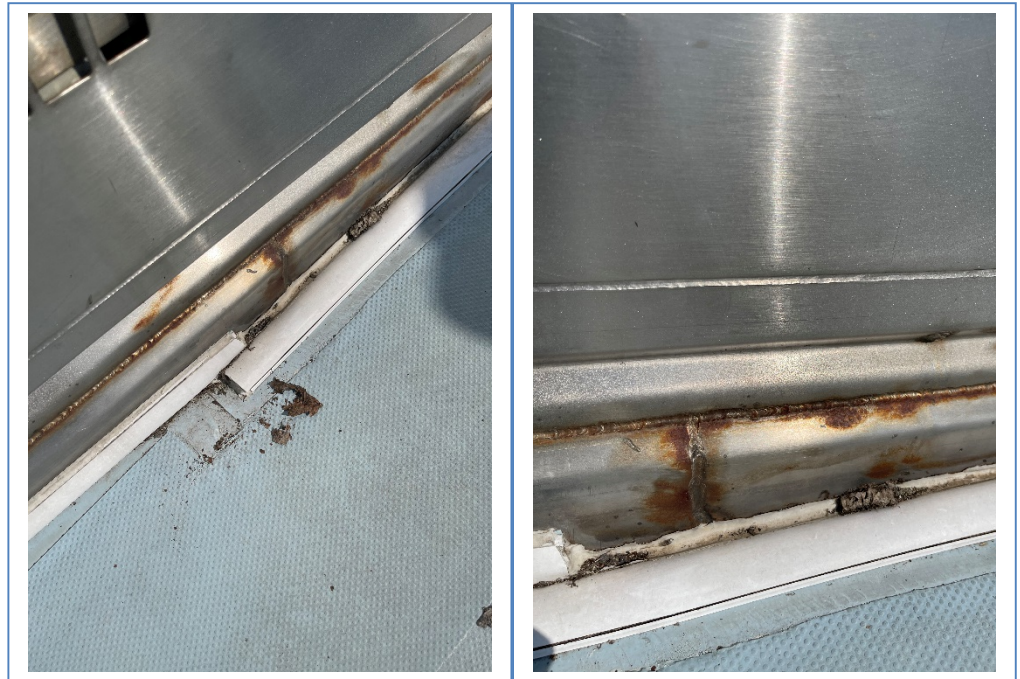
3. The stainless steel perimeter gutter has significant rust on the welds and adjacent weld boundaries. These areas should be cleaned and passivated. Additionally, the entire gutter should be cleaned and polished.

Clean/polish and passivate the stainless steel gutters in the main pool, plunge pool and dive pool.	2	\$12,000 TO \$14,000
Clean the corrosion on the strainers in dive pool/plunge pool/splash pad mechanical room.	2	MAINTENANCE STAFF
Anchor sample stream pumps for the plunge pool and dive pool chemical controllers.	2	MAINTENANCE STAFF
Provide additional supports for the splash pad filtration and backwash piping.	2	MAINTENANCE STAFF

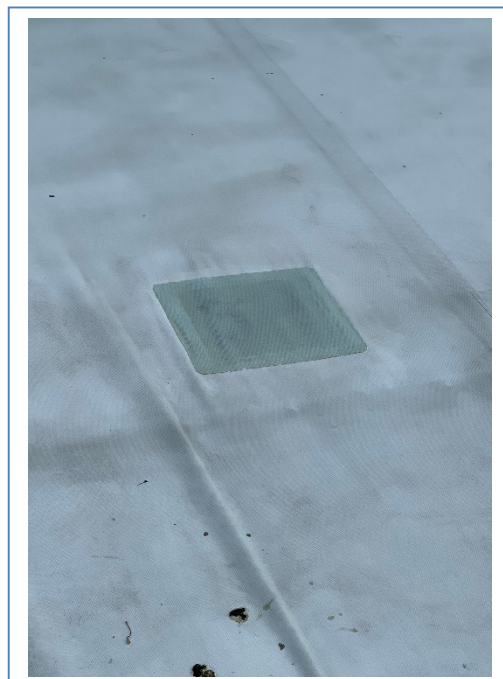
4. The pool PVC liner is 19 years old, well past the useful life. Liners are warranted for 10 years against leakage. The liner has been patched multiple times. Seams require patching every year. Staff indicated that the liner starts to burn rather than melting/fusing, when attempts are made to patch it

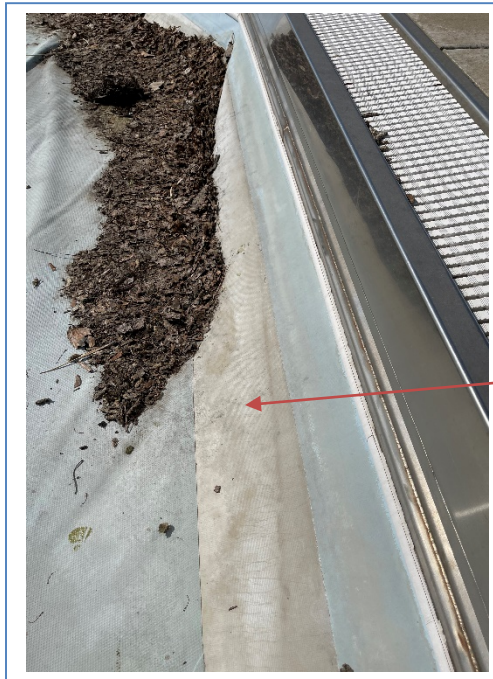
5. The liner has pulled away from the floor and wall at the 2'-0" depth at the northwest zero depth area, creating a large void under it. There is a potential that the liner will tear if stepped on repeatedly by patrons.

LARGE VOID BELOW LINER

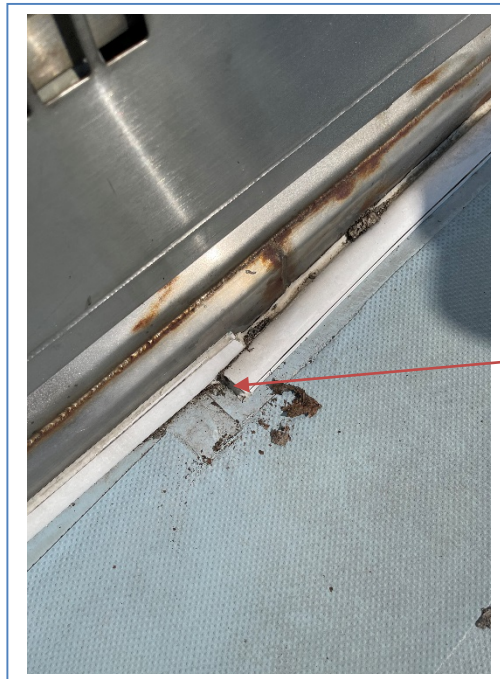
6. Compression strips at the 1'-0" depth in the zero depth area are not installed correctly. Sharp edges are present.

COMPRESSION STRIP
INSTALLED INCORRECTLY.

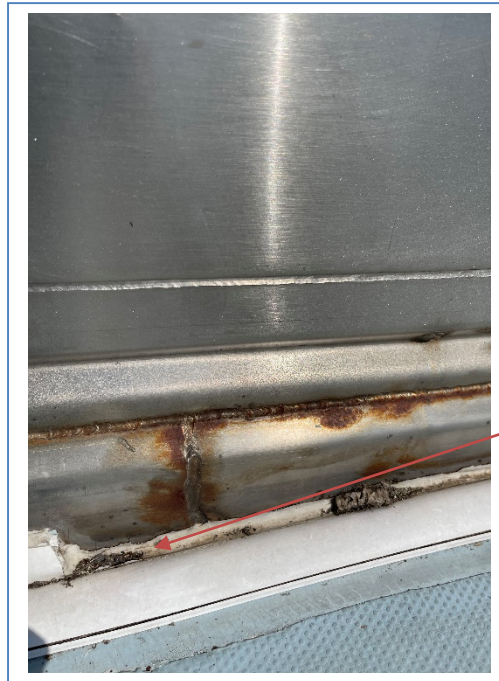
8. The caulk joint under the gutter, and above the compression strip, is in very poor condition.

DETERIORATED CAULK JOINT

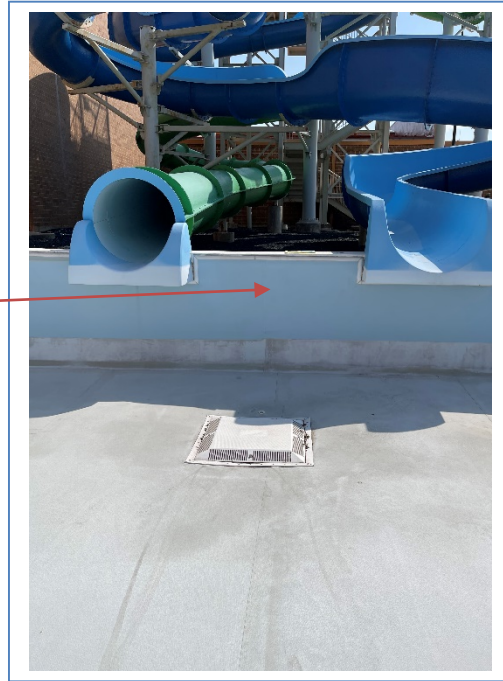
1. The plunge pool wall, where the slide flumes terminate, had significant cracking. The liner was removed, walls repaired and patched.

PLUNGE POOL CONCRETE
WALL REPAIRED AND
PATCHED.

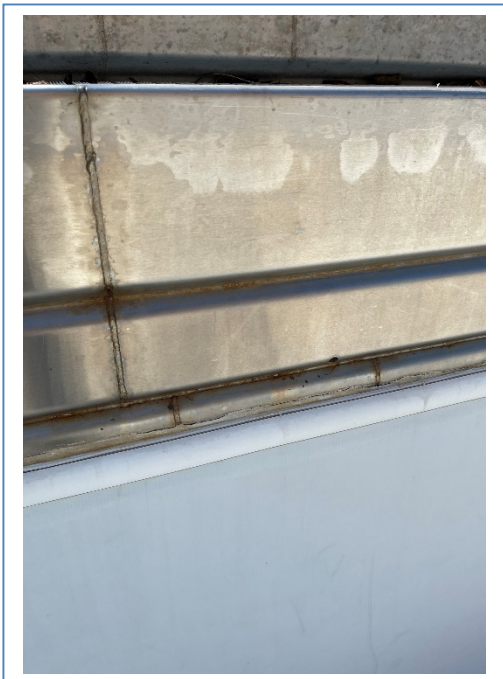
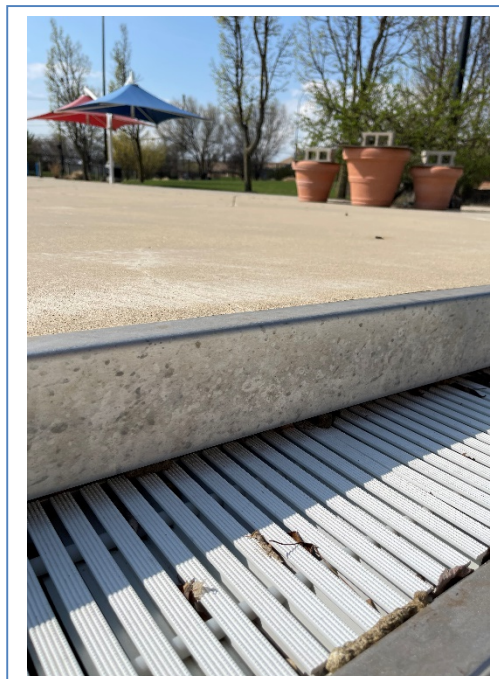
2. Deteriorated/cracked concrete can be felt under the PVC liner by the main drains on the pool floor.
3. The stainless steel perimeter gutter has rust on the welds and on the adjacent weld boundaries. These areas should be cleaned and passivated. Additionally, the entire gutter should be cleaned and polished.

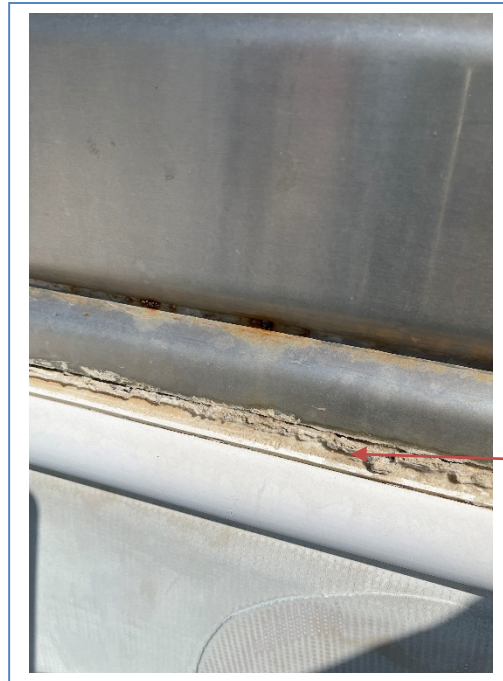
4. The caulk joint under the gutter, and above the compression strip, is in very poor condition

DETERIORATED CAULK JINT

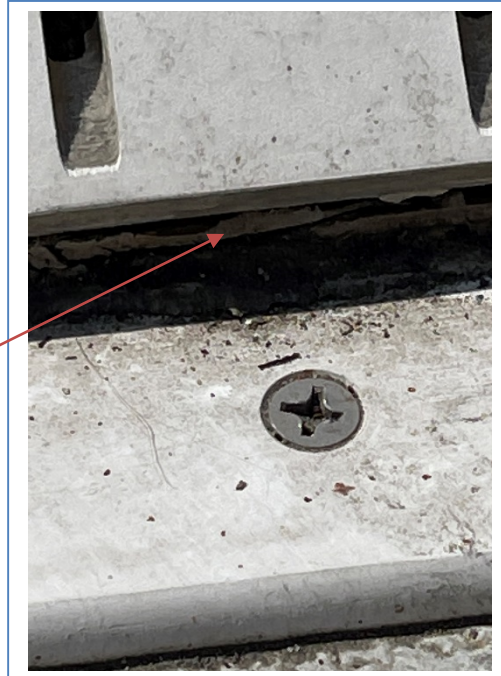
5. Main drain grates need to be recaulked, voids are present.

RECAULK MAIN DRAIN
GRATES

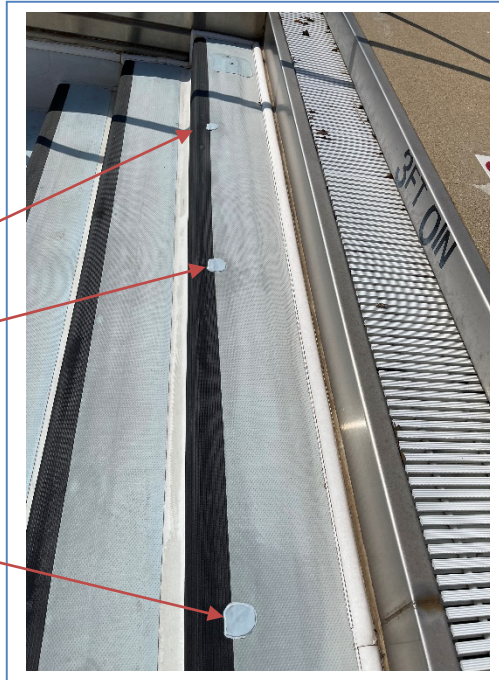
PATCHING

6. The pool PVC liner is 19 years old, well past the useful life. Liners are warranted for 10 years against leakage. The liner has been patched multiple times.

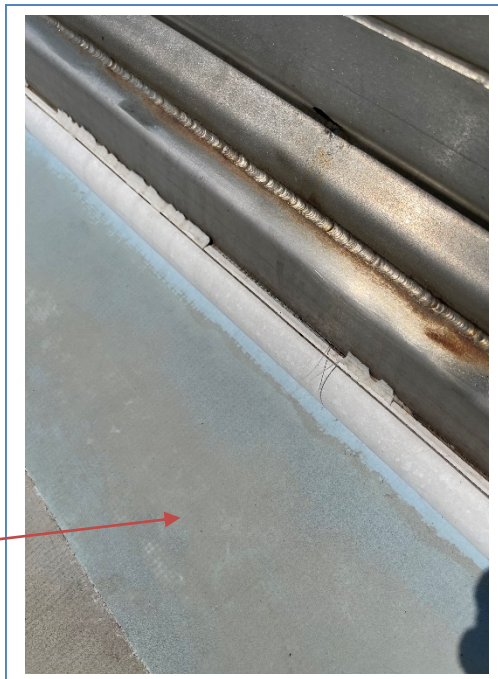
7. The PVC liner is discolored.

LINER IS DISCOLORED

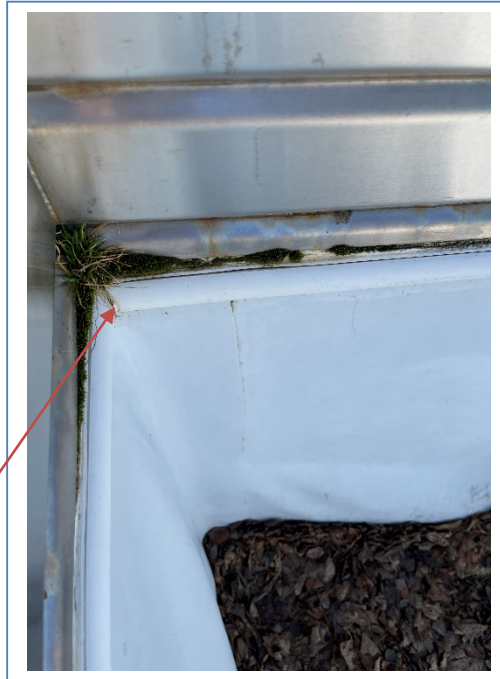
1. The caulk joint under the gutter, and above the compression strip, is in very poor condition. Moss is growing in areas.

DETERIORATED CAULK JINT

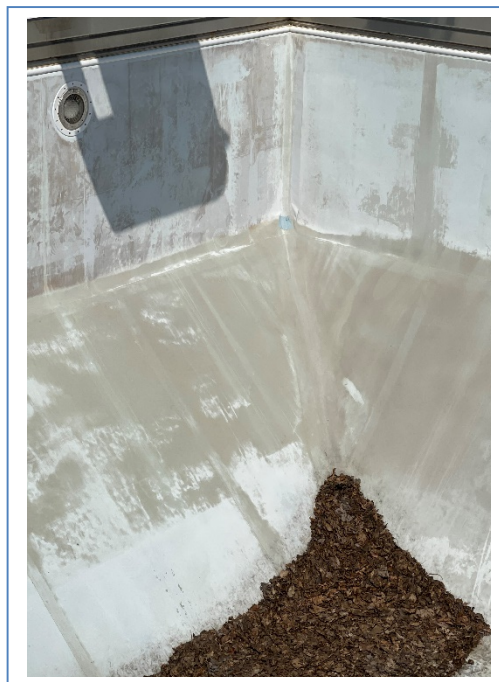
2. The pool PVC liner is 19 years old, well past the useful life. Liners are warranted for 10 years against leakage. The liner is severely stained/faded. The liner is detaching from the wall and floor in the southeast corner of the pool.

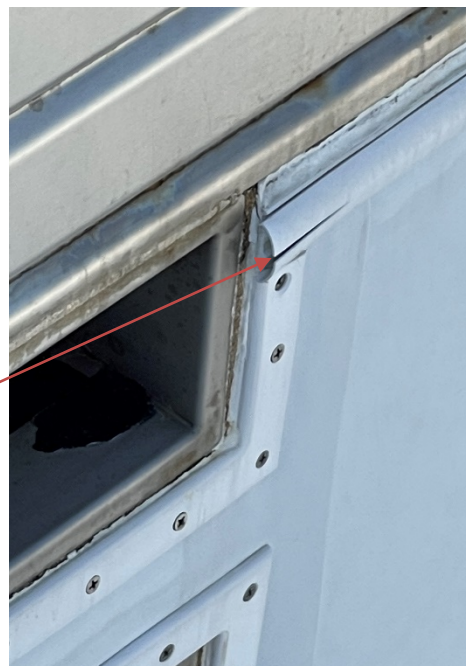
3. The compression strips at the recessed steps are terminated with no end cap. This condition creates a sharp edge and is in need of repair. The compression at the southeast corner recessed steps is cracked.

SHARP END EDGE IS A
HAZARD TO PATRONS.

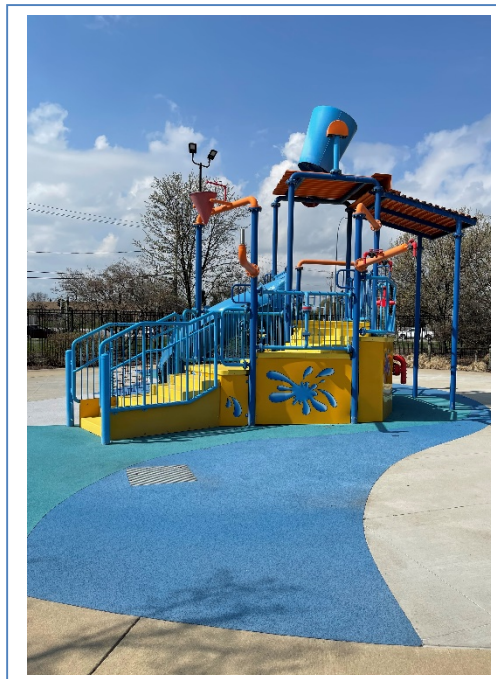
1. The splash pad surfacing and play structure are in very good condition.

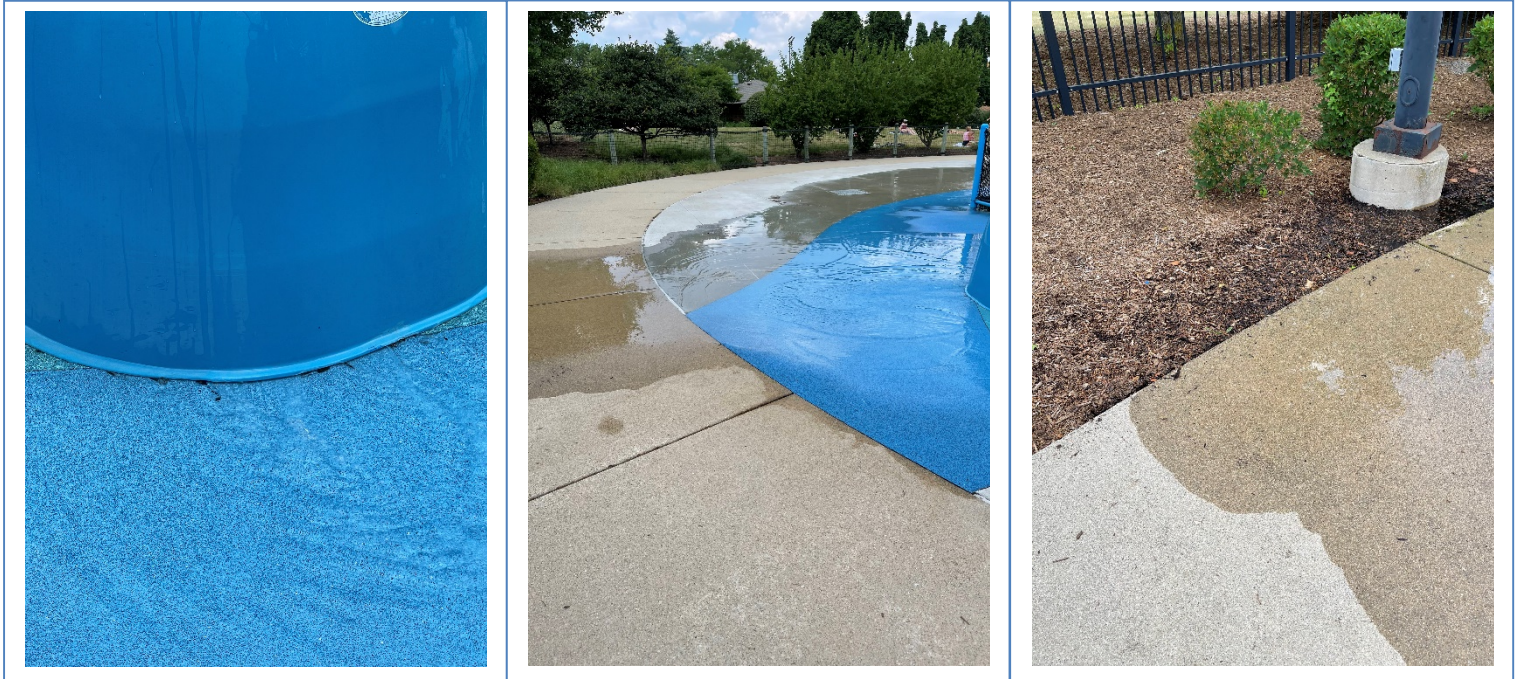
2. The slide runout is leaking from under the flume and pouring across the deck into the landscape area.

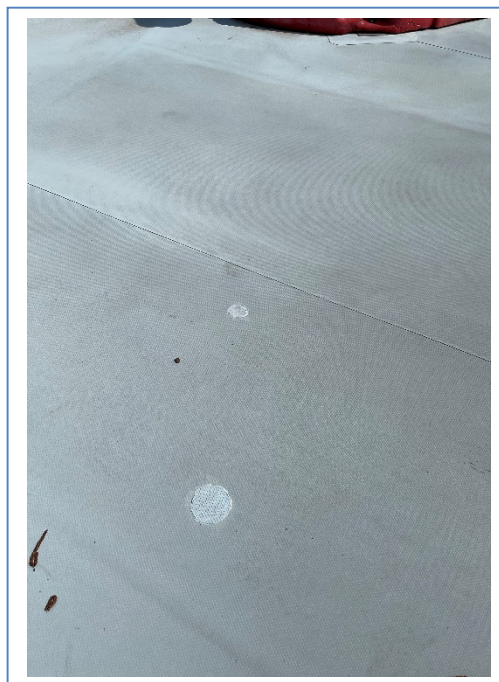
1. The splash pad utilizes a PVC Liner surface. The PVC liner is 19 years old, well past the useful life. Liners are warranted for 10 years against leakage. The liner has been patched.

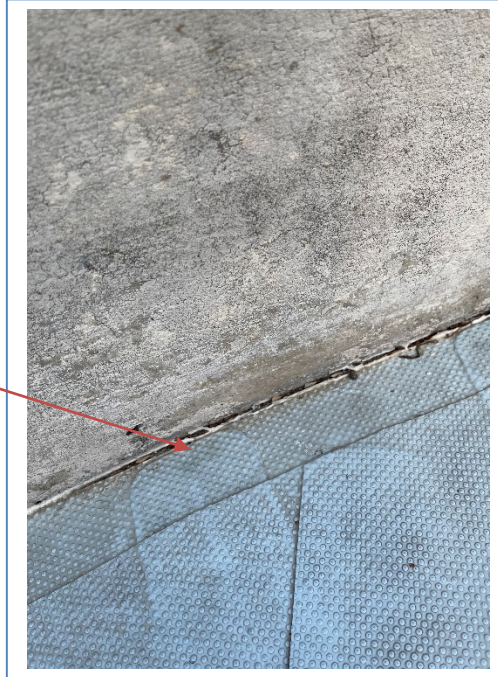
2. The caulk joint at the perimeter wall to liner joint is deteriorated. .

DETERIORATED CAULK JOINT

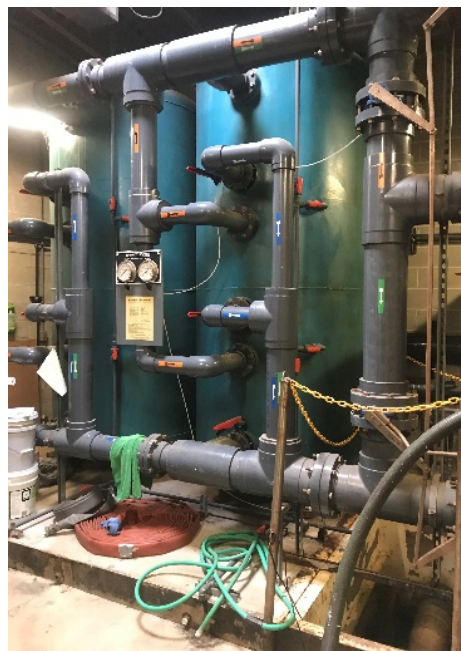
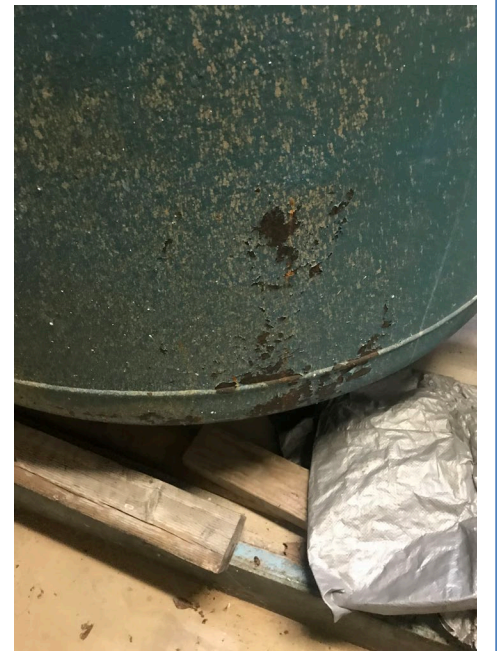
1. The original filter was a vacuum sand filter. In 2000 the original vacuum sand filter was converted into a balance tank and new pressure sand filters were installed on top of the old filter. The existing pressure sand filters have some surface rust and some of the legs also have surface rust, however they appear to be in very good condition.

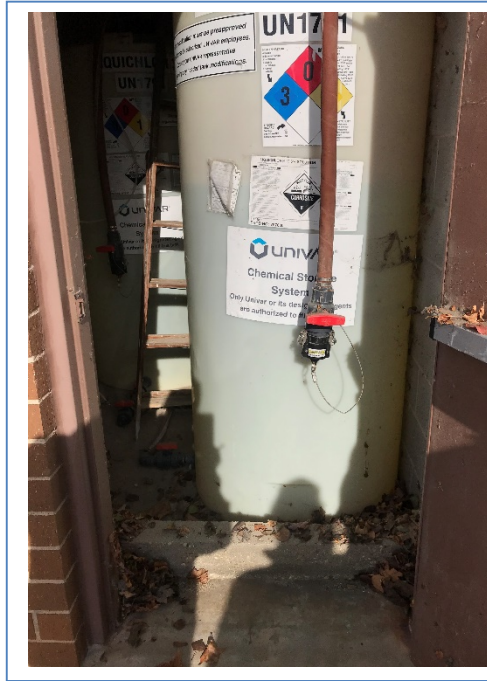
2. The original vacuum filter, which is currently used as a balance tank, appears to be in good condition.
3. The piping, valves and pipe supports are in very good condition.
4. The chlorine storage tank is located in its own chemical storage room. There is minimal containment. A curb was installed to provide containment but the volume is not large enough to contain the volume of the storage tank.

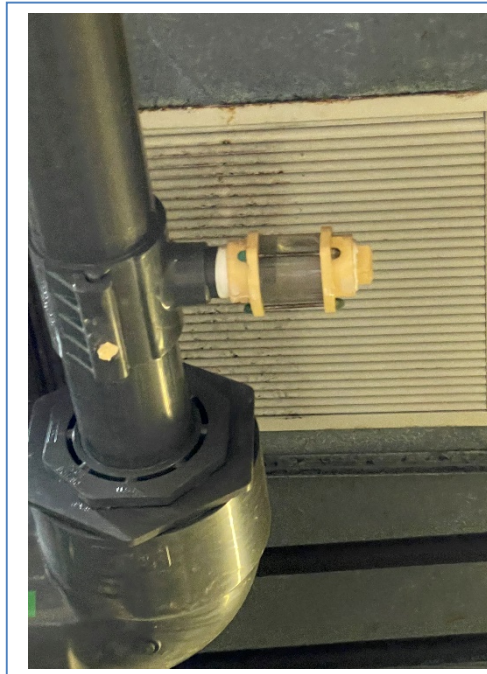
5. Backwash site glass is leaking.

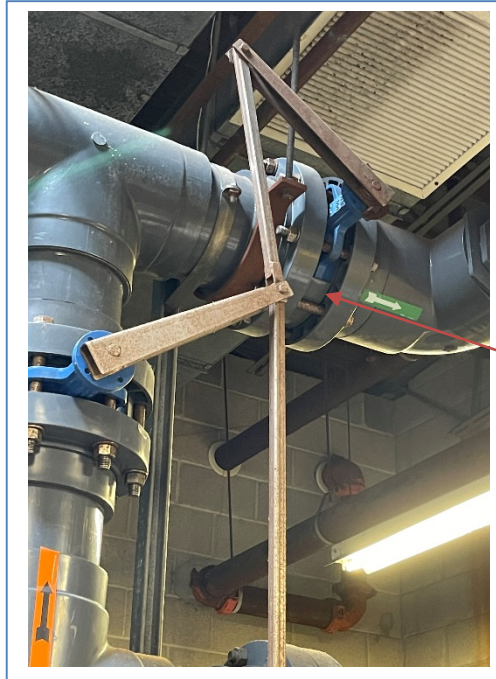
6. The backwash valve on the face piping of the filters is leaking.

BACKWASH VALVE IS
LEAKING

<u>RECOMMENDATION</u>	<u>PRIORITY LEVEL</u>	<u>PROBABLE COST RANGE</u>
Perform leak detection testing for main pool, plunge pool, dive pool, and splash pads on all underground piping.	1	\$5,000 TO \$7,000
Replace the pool liners in the main pool, plunge pool, dive pool and kiddie splash pad. provide a stainless steel skirt on the stainless steel gutters for the compression strip to attach to. This will create a water-tight joint between the liner and gutter and not require a caulk joint.	1	\$600,000 to \$650,000
Recaulk the joint between the liner and the concrete curb wall in the kiddie splash pad.	1	\$2,000 TO \$2,500
Remove the zero depth gutter grating in the main pool and locate and repair all cracked concrete. It is recommended that a structural engineer be involved with the recommended repair methods.	1	ALLOWANCE \$75,000 TO \$100,000
Repalce leaking backwash valve on face piping of main pool filters.	1	\$1,000 TO \$1,500

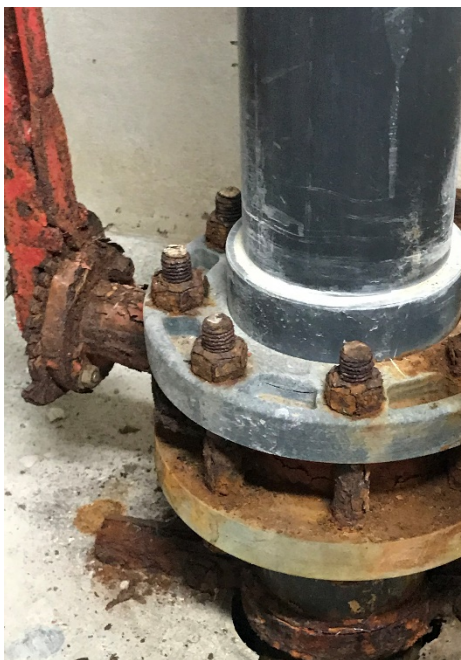
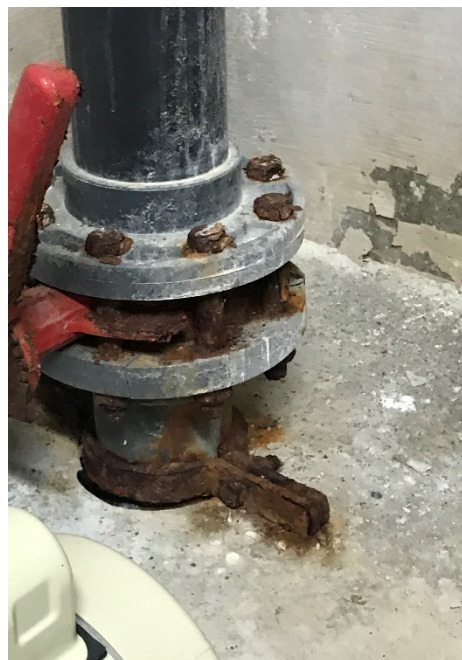
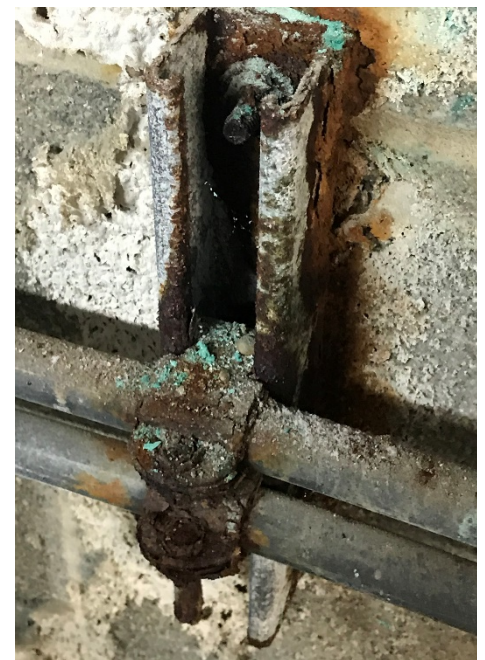
1. The filtration system for the splash pads is located on top of the surge tank and storage reservoir. The tanks off-gas through the stilling lines, fill lines and access hatch. This creates a corrosive environment on top of the tanks. These conditions have severely corroded valves, bolts and supports.

Replace corrodded splash pad valves and supports as required.	2	ALLOWANCE \$4,000 TO \$6,000
Replace filter sand in main pool filters, dive pool/plung pool filter and splash pad filter.	2	ALLOWANCE \$35,000 TO \$45,000

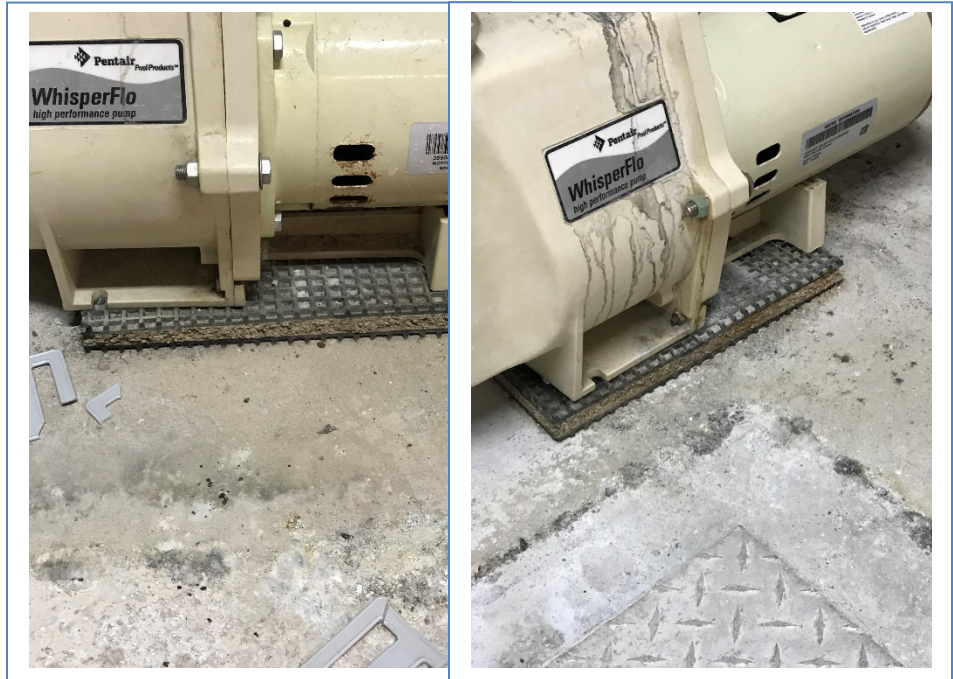
2. The splash pad filtration and backwash piping needs additional support, there is a lot of movement.
3. The sample stream pumps for the plunge pool and dive pool chemical controllers are not anchored to the concrete and could easily move.

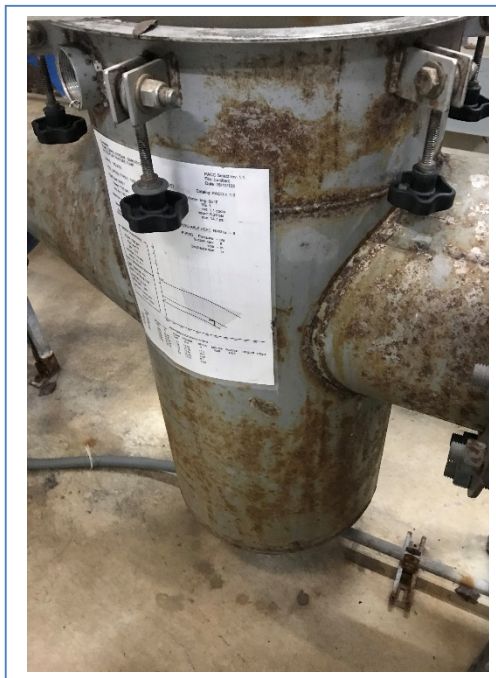
4. There is surface corrosion on the exterior of the strainers. However, the strainers are in great condition on the inside.

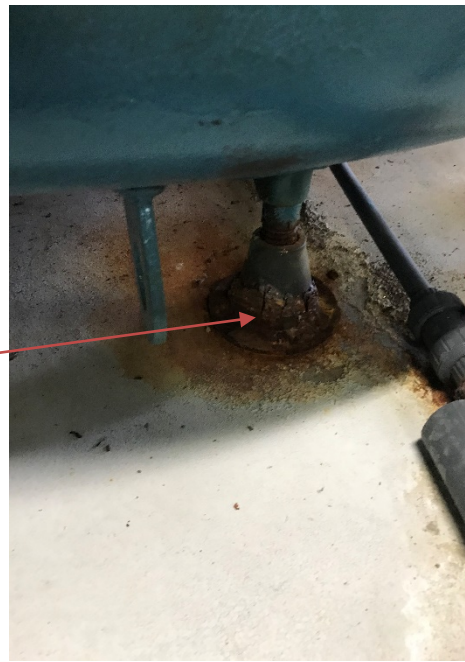
5. The dive pool/plunge pool filter is in good condition. There is some minor surface rust on the legs. The sand in the filter is original.

CORROSION ON FILTER LEGS

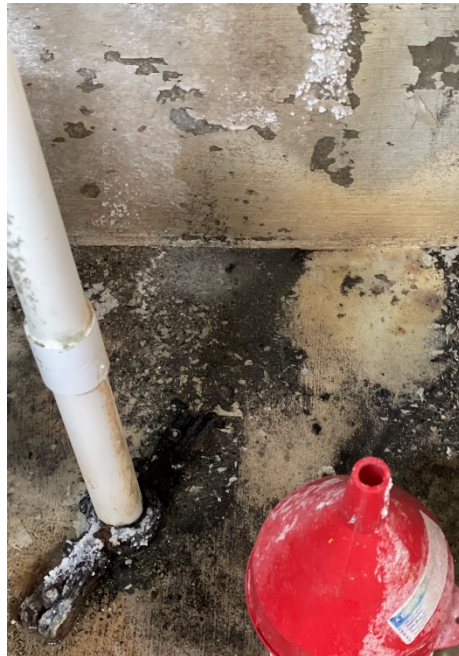
6. The filter for the splash pads is a Pentair TR-140 pressure sand filter. Staff indicated that the filter needs to be backwashed on a daily basis. The sand in the filter is original.
7. The pool heaters are original and working fine per staff. Staff has them serviced every year, replacing parts as necessary.
8. The chlorine injection is leaking at the elbow and at the valve connection for the splash pads. This is causing severe corrosion for the support for the stilling line.
