**September 8, 2021**

**Mechanical & Plumbing  
Existing Conditions Assessment**

**Coral Cove Pool Mechanical Rooms  
849 W Lies Rd  
Carol Stream, IL 60188**

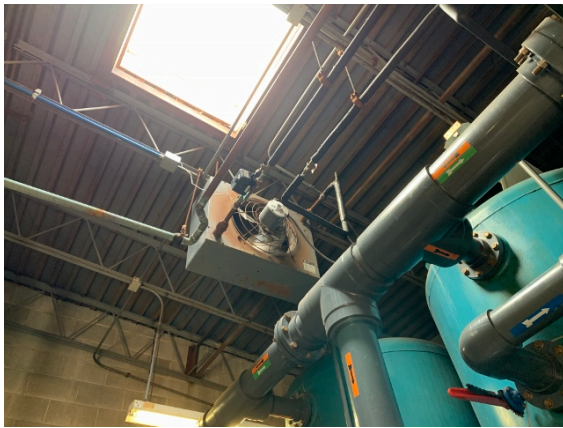
Hot water unit heater

The exhaust fan on the roof was inaccessible during the inspection, so the condition of the fan is unknown at this time. Hot water unit heater unit heater appeared to be over 20 years old and is showing some exterior corrosion. The air handler is over 30 years old, and appeared in fair condition. The boilers are in good condition.

Verify proper operation of exhaust fan on roof. The hot water unit heater is nearing the end of its useful life. Replacement should be considered.

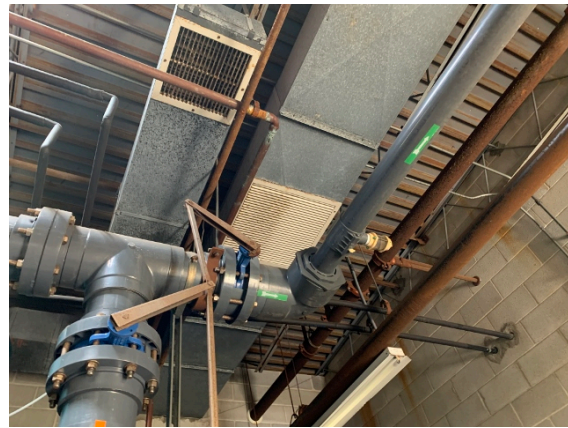
Supply and exhaust vents

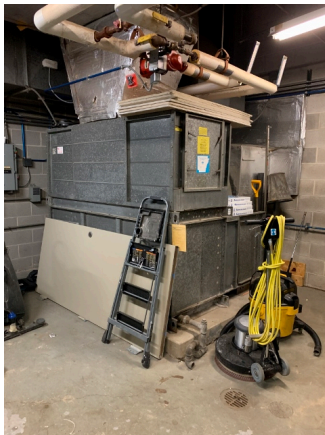
Air handler in Boiler Room

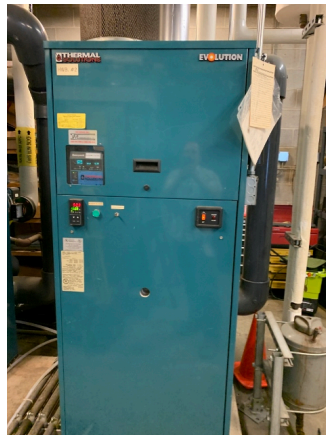
Boiler (1 of 2)

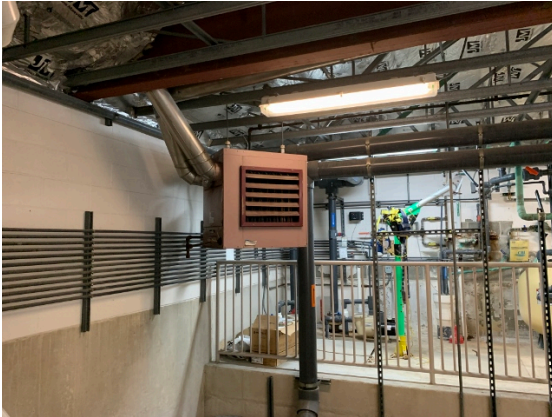
Gas-fired unit heater

The unit heater and exhaust fans appeared to be in good condition. It was reported that the exhaust fan seems undersized as there are corners of the room with piping experiencing higher rates of corrosion.

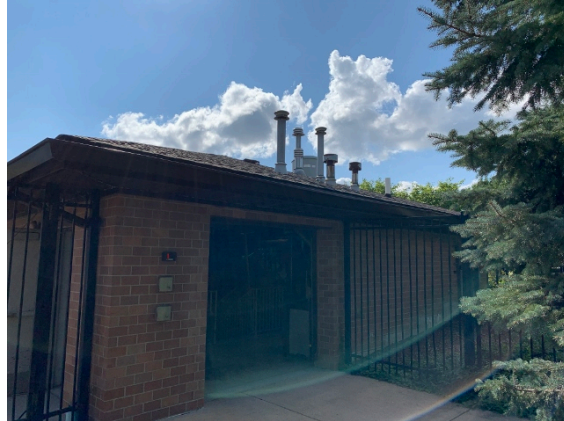
Vents and Exhaust fan on roof

Consider adding additional exhaust in area that is experiencing higher corrosion.

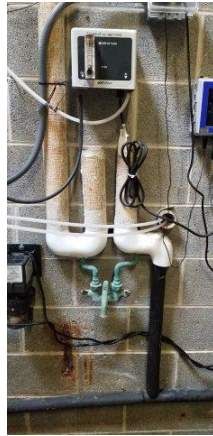
Hose Connection

The hose connection does not have backflow protection.

Provide screw-on vacuum breaker for hose connection.

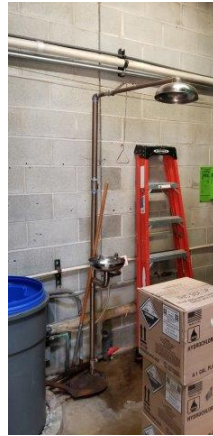
Emergency Shower

The emergency shower does not have a hot water connection. It does not utilize an ASSE 1071 emergency mixing valve to provide tepid water.

Add hot water to emergency shower with ASSE 1071 mixing valve.

If the emergency shower is provided with the required tepid water, a second 200 MBH water heater will need to be added to meet OSHA requirements (20 GPM of tepid water for 30 minutes)

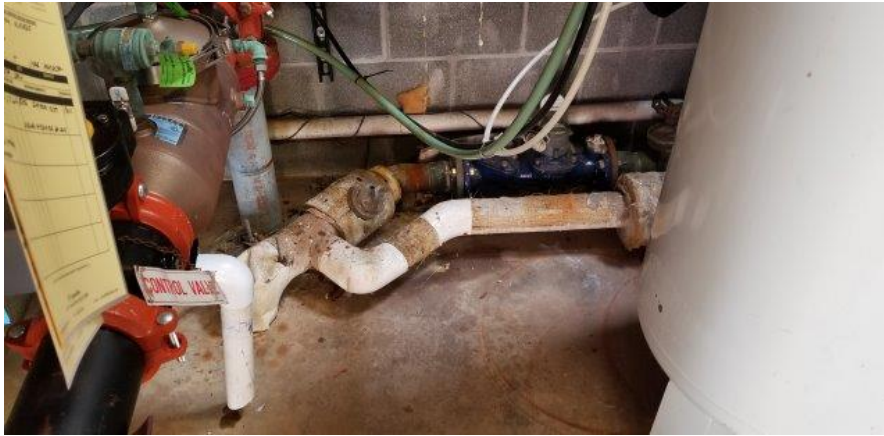
Domestic water service & meter

IDPH requires combined fire protection and domestic water services. Separate water services for fire suppression and domestic use and no longer permitted.

If the building undergoes a renovation, the domestic water should be fed from the existing fire suppression service. The domestic service shall be removed. If the 4" service is not adequate to support the demand of FP and domestic, provide a new combined 6" water service.

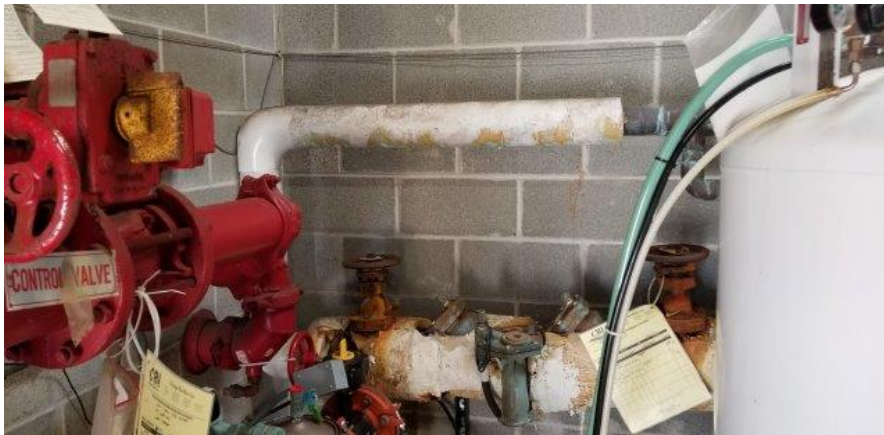
Domestic RPZ

The RPZ is in poor condition

Provide new RPZ for domestic water service

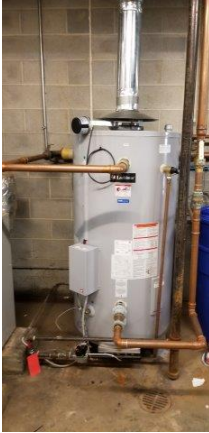
Domestic WH

The water heater is in good condition.

The water heater does not have a thermal expansion tank or vacuum relief valve

Provide thermal expansion tank and vacuum relief valve for water heater

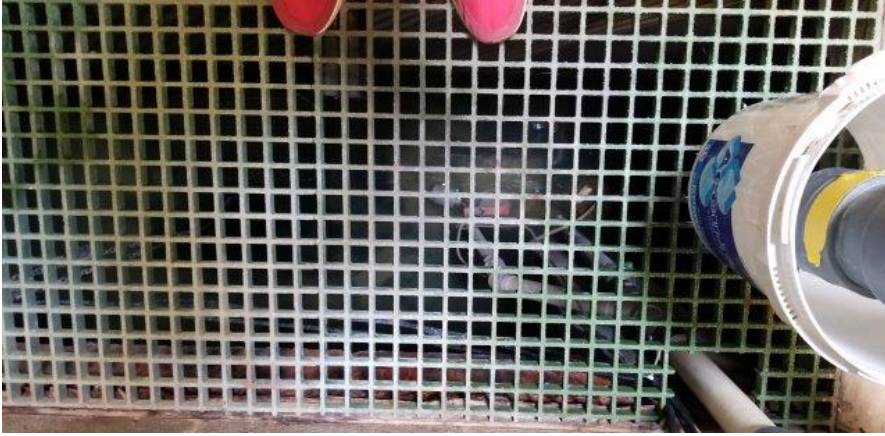
The backwash pit is served by two submersible pumps. According to staff, one pump is not functional. The pumps lift the backwash water to the hub drain located within the room.

Backwash Pit Grate and pumps below

Remove abandoned sump pump.

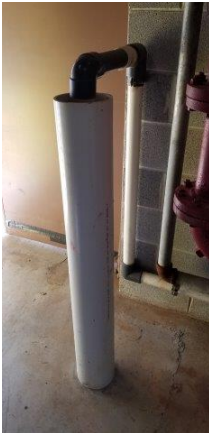
Hub Drain

Air gap is not 6" per IDPH requirements.

Provide 6" air gap for backwash discharge.

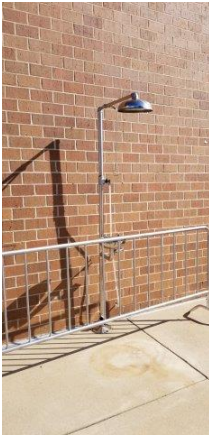
Deck shower

The shower is technically an emergency shower employed for pool deck usage. This would eliminate the temporary metal gate that is used to prevent access to the emergency eyewash.

Consider a metering shower valve and showerhead for use on the pool deck. Also provide hot water and a mixing valve to provide tempered water to the shower, if desired.

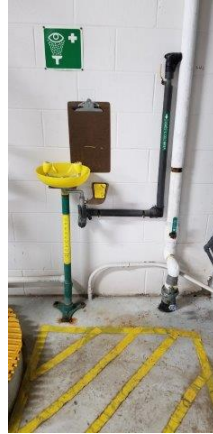
Emergency Shower

The emergency eyewash does not have a hot water connection. It does not utilize a mixing valve to provide tepid water.

Provide hot water to emergency eyewash and add mixing valve.

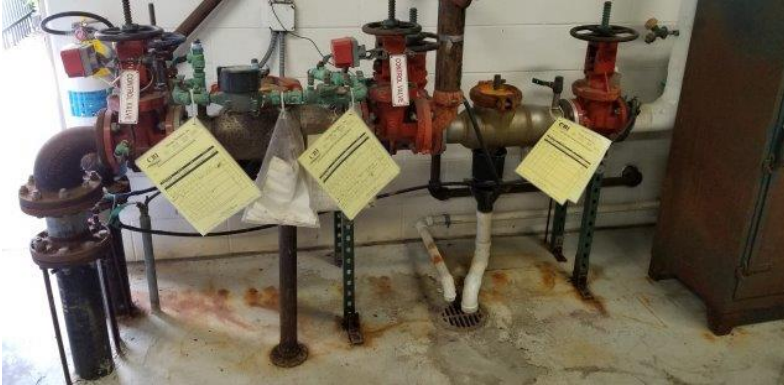
Domestic & FP water services

The meter and RPZ appear to be in good condition.

IDPH requires combined fire protection and domestic water services.

If the building undergoes a renovation, the domestic water should be fed from the existing fire suppression service.

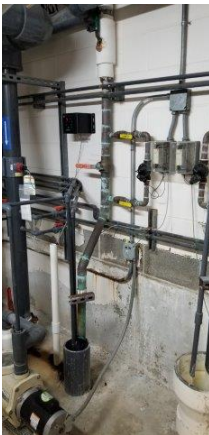
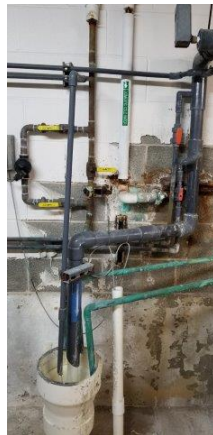
Pool Fill

Provide sub-meters for pool fills per operator's request.

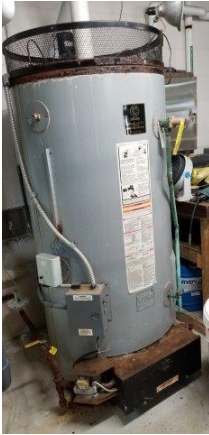
Domestic WH

The water heater is not functional. The mixing valve is abandoned.

Emergency eyewash is not provided with tepid water.

Provide water heater and mixing valve to serve emergency eyewash. The heater size may be reduced significantly.

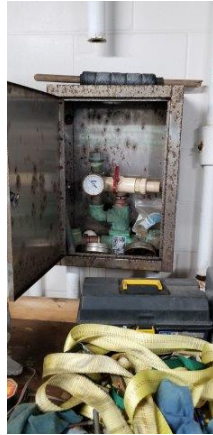
Mixing Valve
