**September 8, 2021**

**Mechanical & Plumbing  
Existing Conditions Assessment**

**Coral Cove Pool Mechanical Rooms  
849 W Lies Rd  
Carol Stream, IL 60188**

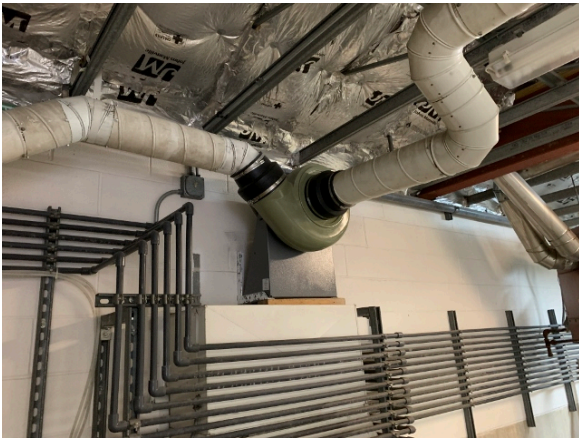
Utility fan for Chemical room

The unit heater and exhaust fans appeared to be in good condition. It was reported that the exhaust fan seems undersized as there are corners of the room with piping experiencing higher rates of corrosion.

Consider adding additional exhaust in area that is experiencing higher corrosion.

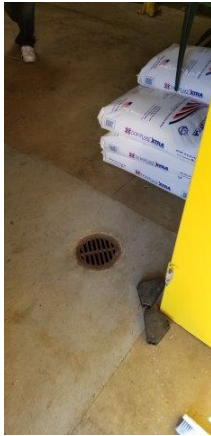
Floor Drain

The fixtures and equipment are in fair condition.

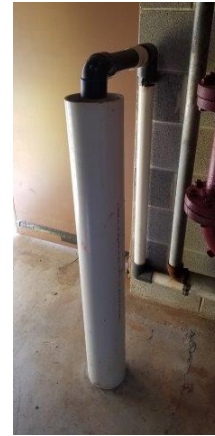
Hub Drain

The pool mechanical room has a floor drain, a hub drain, a hot/cold hose connection, an emergency shower and a backwash pit with sump pumps. One sump pump is abandoned. The hub drain serves the backwash pit sump pump discharge.

The only portion of exposed waste and vent piping is the 4" hub drain. It is constructed of Schedule 40 PVC. Based on the age of the building, it is likely that original piping is service weight cast iron.

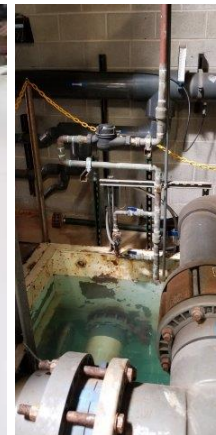
1-1/2" pool fill & meter

The building is served by separate domestic and fire protection water services. The domestic service has a 3" water meter, valves and RPZ. There is a 1-1/2" pool fill with air gap and water meter.

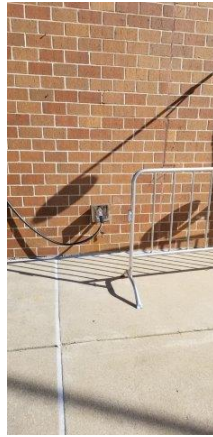
Wall hydrant

The condition of the fixtures appears to be good.

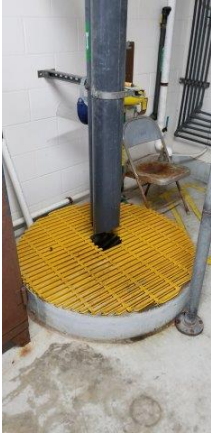
Backwash Pit

The fixtures and equipment are in fair condition.

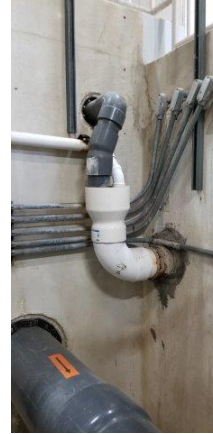
Hub Drain

The pool mechanical room has several floor drains, a large hub drain, hose connections, an emergency eyewash and a backwash pit. The hub drain receives discharge from pool equipment (Schedule 80 PVC) and the sump pump.

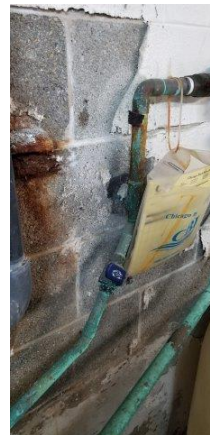
Irrigation water & drain down (RPZ not in pic)

The meter and RPZ appear to be in good condition.

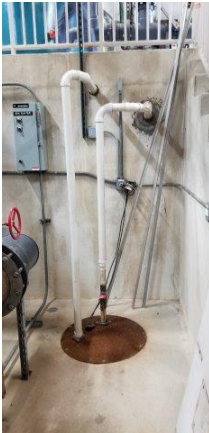
Sewage Ejector

The recessed well is served by a sewage ejector pump and a sump pump. The sewage ejector serves the floor drain in the well. The sump pump likely serves drain-tile around the well's footings. The sump pump drains to the hub drain. The sewage ejector is force main to the underground sanitary sewer.

The condition of equipment appears to be fair to good.

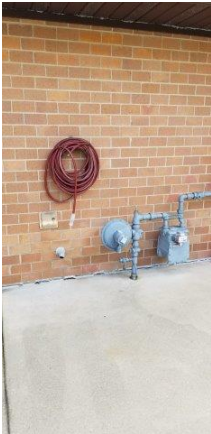
Hose Connection

The condition of the equipment is fair to good.
